# Manhole Inspection Summary

Manhole # S21KK1009MH

Insp Date: **11/20/06 10:02 AM**

**Location** Address: **4434 CLYDESDALE AVE** Cross Street: **BUENA VISTA AVE**

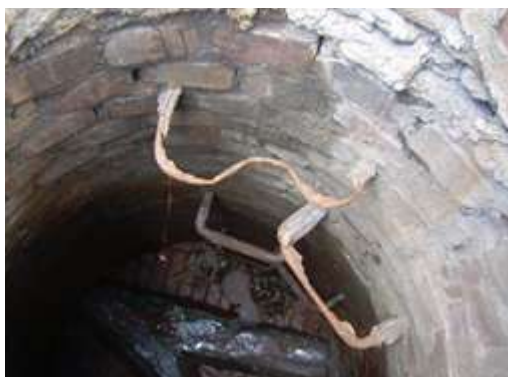
Defect

**Corbel** Material: **Brick** ☐ Parged Type: **Concentric/Eccentric**  
Condition: ☐ Sound ☐ Cracked ☐ Root Intrusion ☐ Loose Brick ☒ **Deteriorated**  
Infiltration: ☐ None ☐ Joint ☐ Cracks ☒ **Mortar** ☐ Roots ☒ **Wall**

**Barrel** Material: **Brick** ☐ Parged  
Shape: **Circular** Diameter: **42** (in.) Length: (in.)  
Condition: ☐ Sound ☐ Cracked ☐ Root Intrusion ☐ Loose Brick ☒ **Deteriorated**  
Infiltration: ☐ None ☐ Joint ☐ Cracks ☒ **Mortar** ☐ Roots ☒ **Wall**

Corbel deterioration and infiltration. Barrel infiltration - other side.

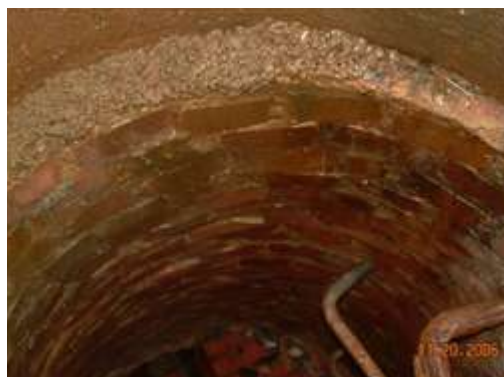
Defect

**Frame** Offset: **2** (in.) Condition: ☐ Sound ☐ Cracked ☒ **Leaks**

**Chimney / Frame Adjustment** ☒ Exists Material: **Brick** ☐ Parged Height: **7** (in.)  
Condition: ☐ Sound ☐ Cracked ☐ Root Intrusion ☐ Loose Brick ☒ **Deteriorated**  
Infiltration: ☐ None ☒ **Joint** ☐ Cracks ☒ **Mortar** ☐ Roots ☐ Wall

Frame leaks. Frame offset. Adjustment deterioration and infiltration.

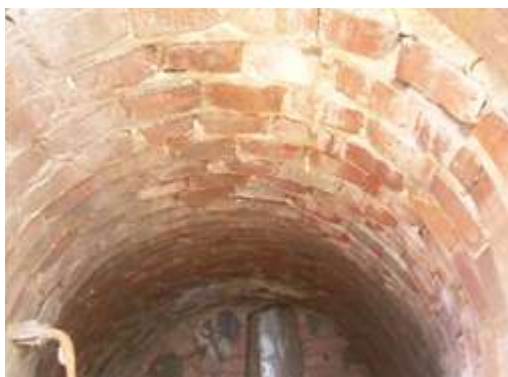
Defect

Corbel deterioration and infiltration. Barrel infiltration.

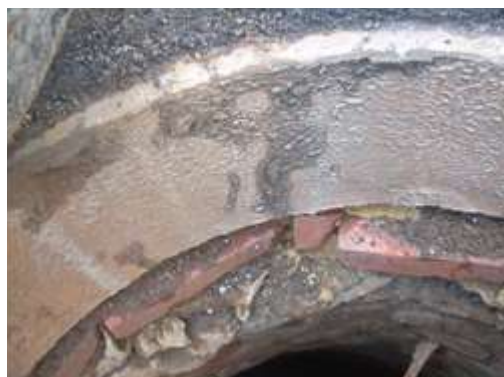
Defect

Frame leaks. Frame offset. Adjustment deterioration and infiltration.

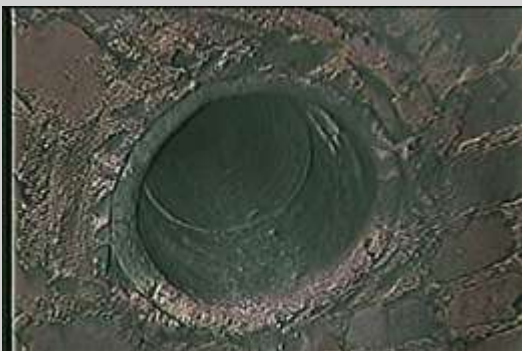
### 8 in. Circular Gravity Sewer Pipe In @ 4 O'Clock

Infiltration: **Evidence** Pipe Seal Cond: **Cracked**

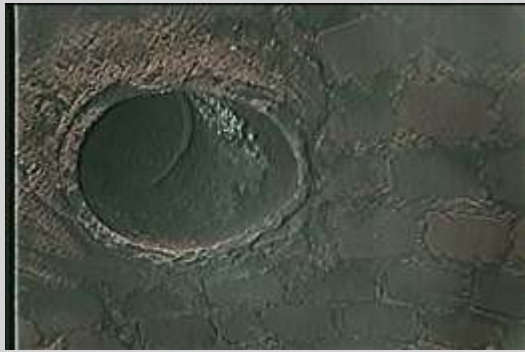
Pipe In @ 7 O'Clock

Infiltration: **Evidence** Pipe Seal Cond: **Cracked**

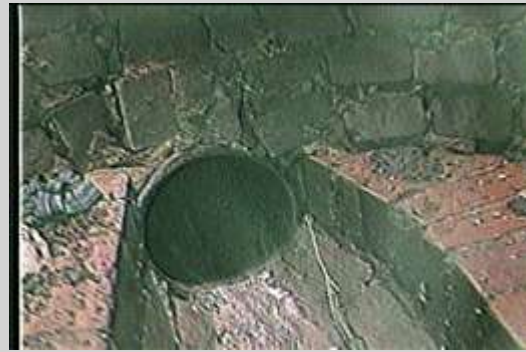
Drop In @ 7 O'Clock

**Channel** Material: **Brick** ☐ Parged ☐ Debris (not Condition related)  
Channel Exposure: **Fully Open** Junc Dist: **0** nearest .5 ft. Azimuth:  
Condition: ☐ Sound ☐ Cracked ☒ **Root Intrusion** ☒ **Deteriorated** ☐ Leaks ☐ Debris

Barrel deterioration and infiltration. Channel deterioration and root intrusion.
